Greenjacket® Precise fit cover-up delivers reliability, cost-effectively:

Big 3 Automotive Engine Manufacturing Plant Adopts Greenjacket to Prevent Animal and Bird Caused Power Outages at Power Supply Substation

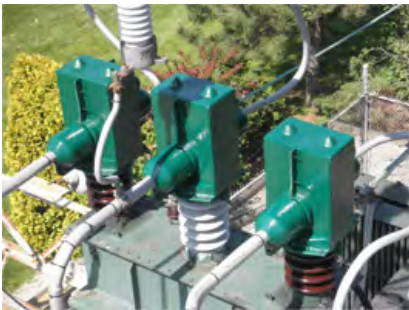
Precise Fit Cover-up for Energized Metering Equipment at Big 3 Automotive Manufacturing Facility

The Greenjacket® solution utilizes photogrammetric imaging as the basis to manufacture a precise-fit cover-up product made from a highly dielectric, polyurea material that meets the IEEE 1656 industry guideline for bird and animal cover-up.
